# Appendix A

## Actions on Previous MDPH Recommendations

The following is a status report of actions taken on MDPH recommendations (**in bold**). The summary is based on reports from the Saugus Inspectional Services/Building Department, Saugus School Department Officials, and documents, as well as photographs and observations made by MDPH staff.

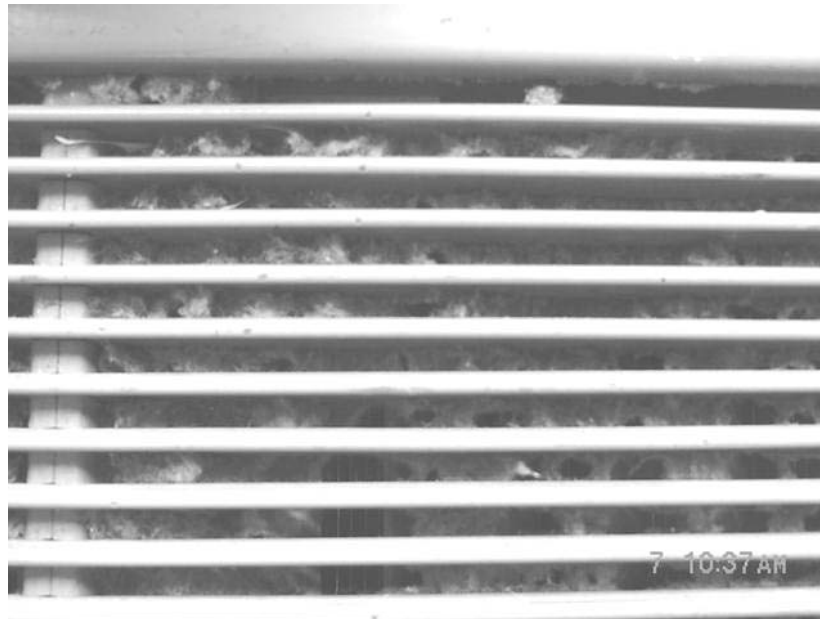
**Picture A-1**

**Action Taken:** Blockages were removed and staff were instructed not to prevent airflow. CEH staff inspected the interior of univents and found several of them with dust/debris accumulation and cobwebs (Pictures A-1 and A-2).

**Action Taken:** Overall clutter was reduced, more work needs to be done in certain areas. Dust control and general cleaning needs to be improved, especially inside unit ventilator cabinets (Picture A-1 and A-2)

**Dust/Debris in Classroom Univent Air Diffuser**

- **Remove all blockages from univents and exhaust vents. Clean out interiors of univents regularly (e.g. with filter changes).**

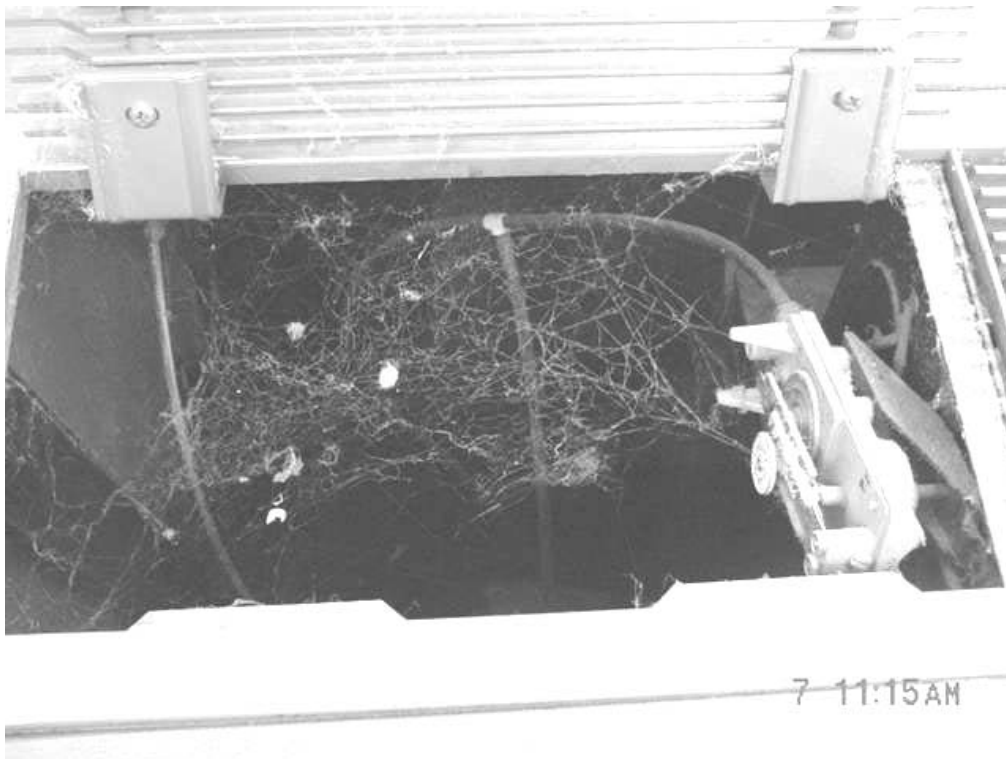
**Picture A-2**

**Cobwebs in Classroom Univent Cabinet**

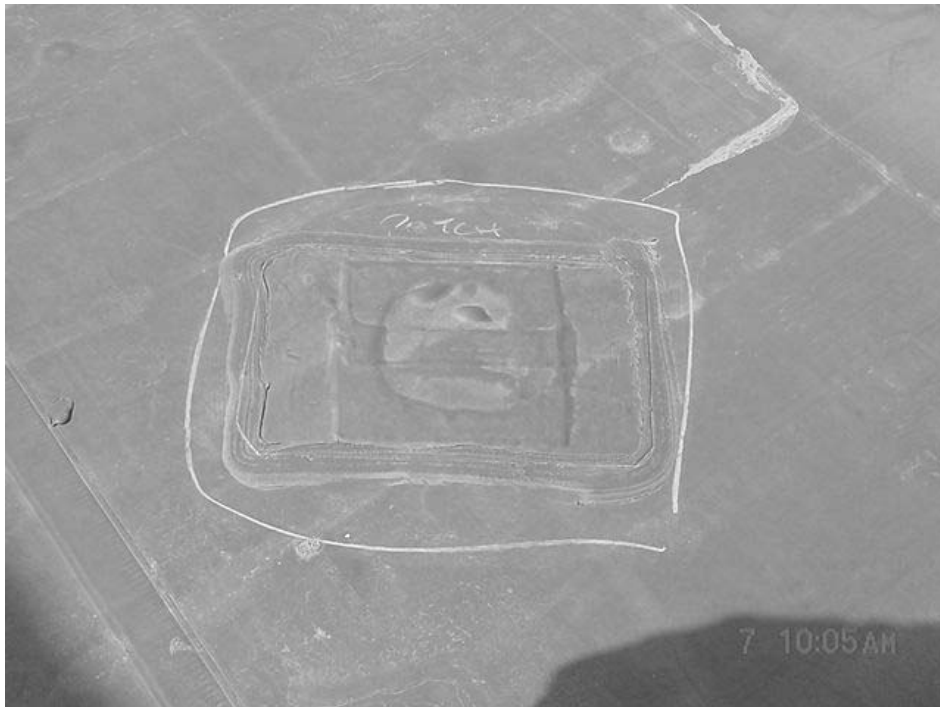
**Picture A-3**

**Action Taken:** The roof has been repaired/patched in a number of areas (Pictures A-3 and A-4). Leak-prone areas around the gym/cafeteria have been sealed and flashing has been installed/repared (Pictures A-5 and A-6). No current leaks were reported or observed. In addition, the Saugus Building Department reported that they have contracted with a roofing company to conduct an annual assessment to provide a written report on roof conditions.

**Roof Patch**

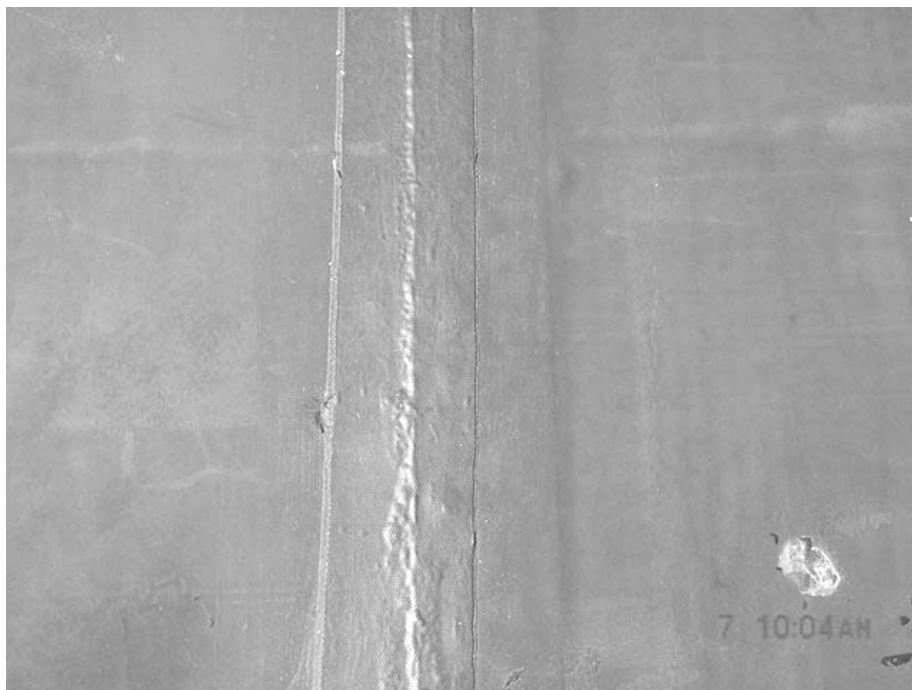
**Picture A-4**

**Sealed Roof Seam on Rubber Membrane**

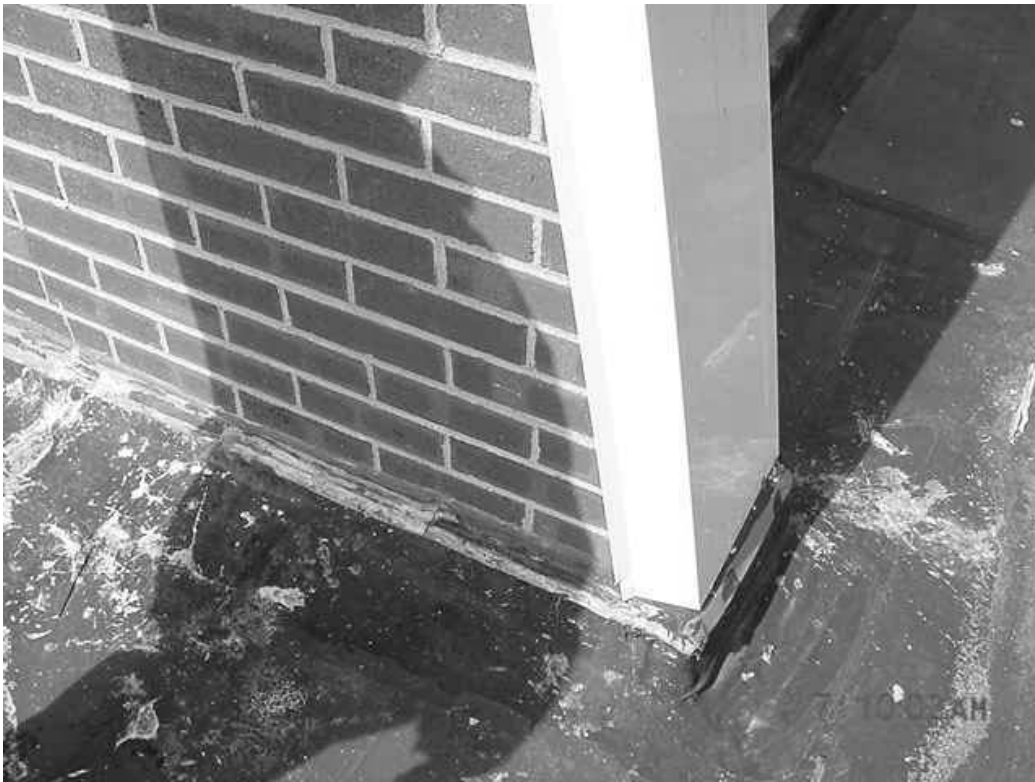
**Picture A-5**

**Flashing Installed over end of Masonry in Area of Leaks in the Gym/Cafeteria**

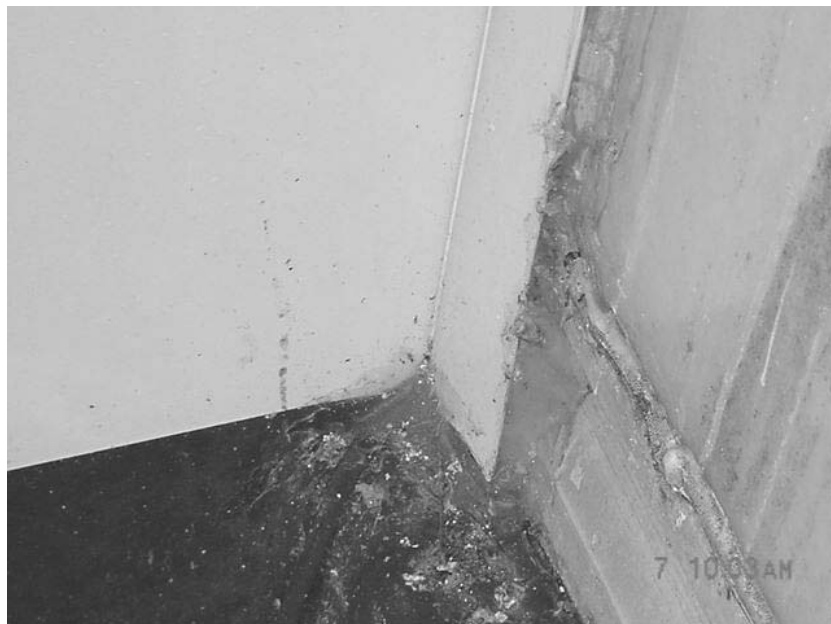
**Picture A-6**

**Sealant Compound in Area of Leaks in the Gym/Cafeteria**

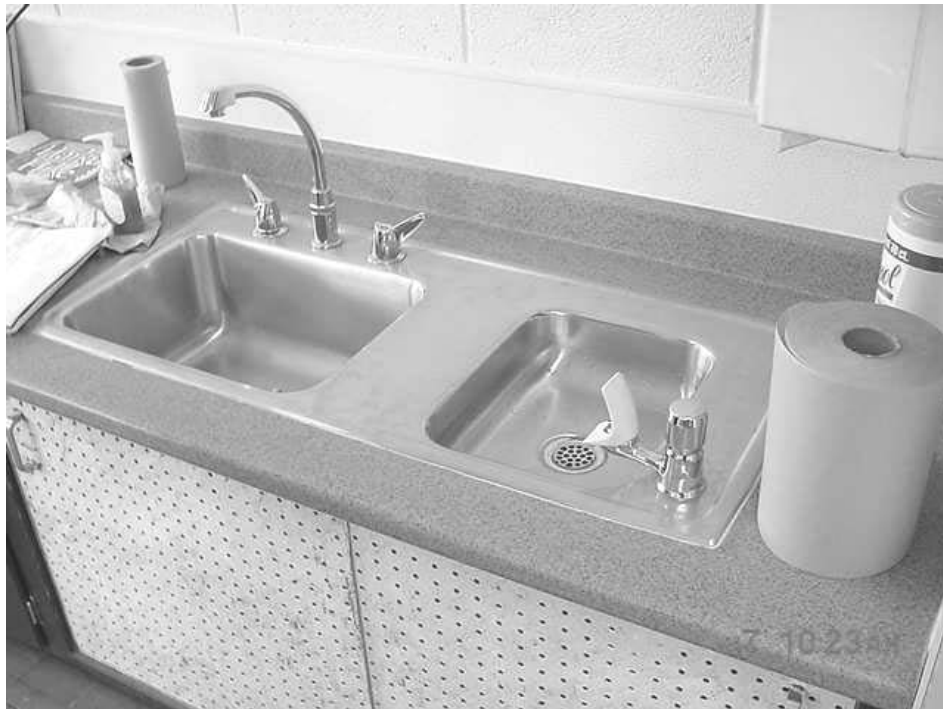
**Picture A-7**

**Action Taken:** Several of the countertops were replaced with molded one piece countertops (Picture A-7). A number of classrooms were observed during the reassessment with spaces between the sink and backsplash (Picture A-8).

**One-Piece Molded Countertop in Classroom**

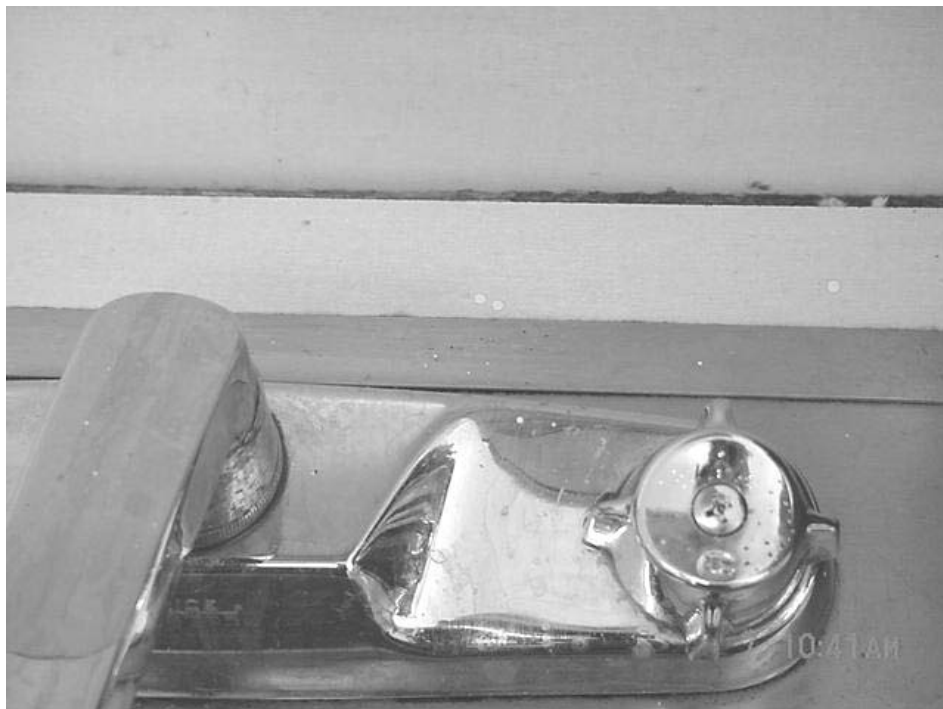
**Picture A-8**

**Spaces between Sink Countertop and Backsplash**

- **Seal areas around sinks to prevent water-damage to the interior of cabinets and adjacent wallboard. Inspect wallboard for water-damage and mold/mildew growth, repair/replace as necessary. Disinfect areas of microbial growth with an appropriate antimicrobial as needed. Consider replacing with one-piece, molded countertops.**

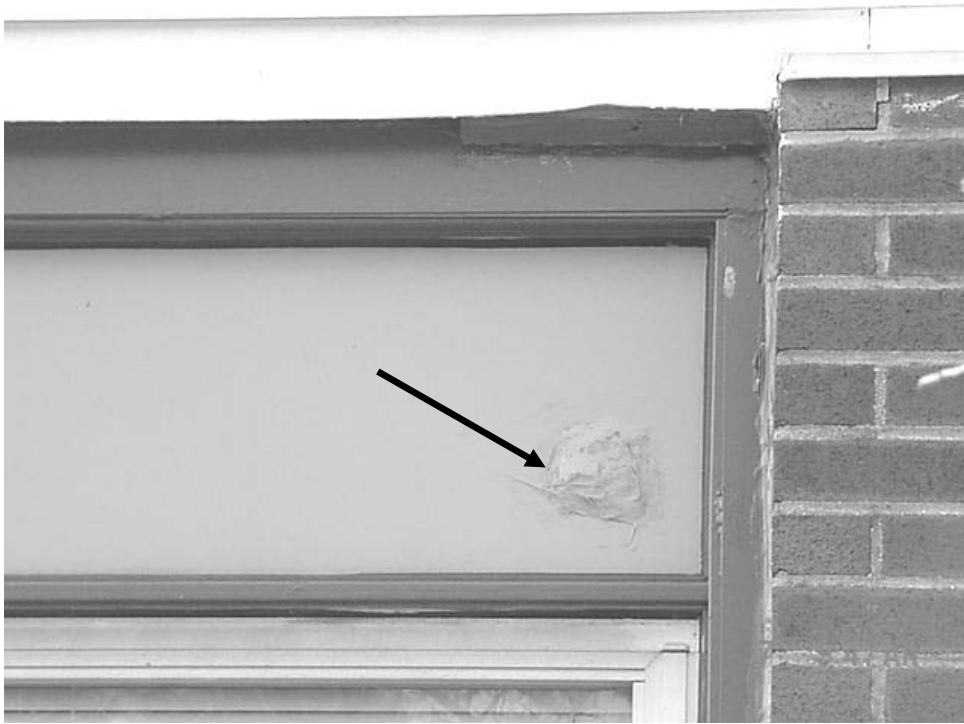
**Picture A-9**

**Action Taken:** The hole on the exterior of the building was sealed (Picture A-9).

**Sealed Hole in Exterior Wall Panel**

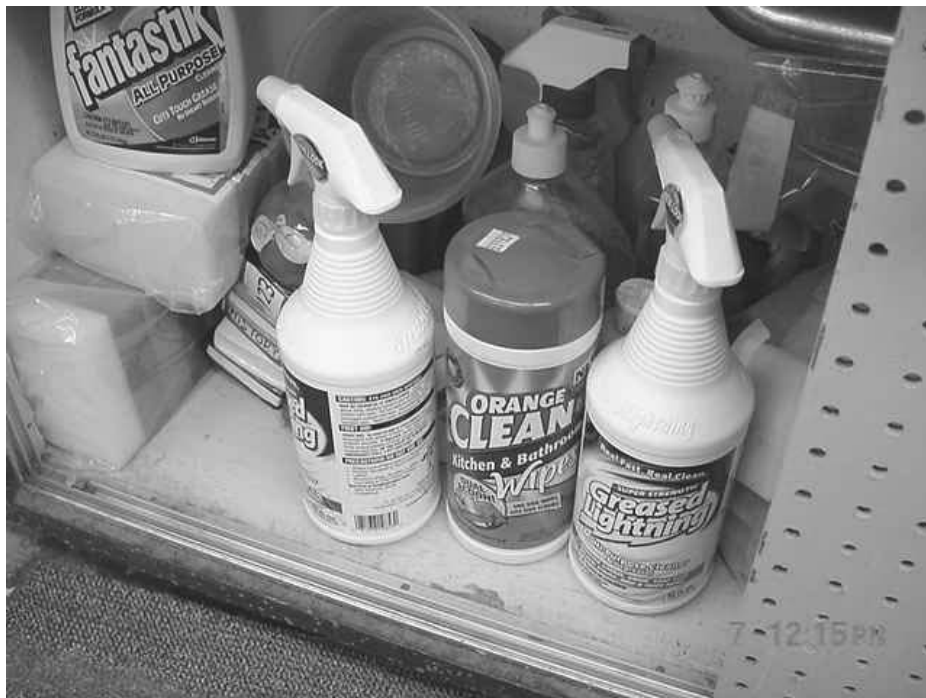
**Picture A-10**

**Action Taken:** Cleaning products continued to be stored in unlocked cabinets and on countertops in reach of children (Picture A-10). Many of these products appeared to be brought from home without the knowledge of school personnel who maintain material data safety sheets (MSDS) for chemicals used in the school. Therefore it is unlikely that MSDSs for these materials are available on site.

**Spray Cleaning Products and Degreaser under Classroom Sink**

- **Store cleaning products properly and out of reach of students.**

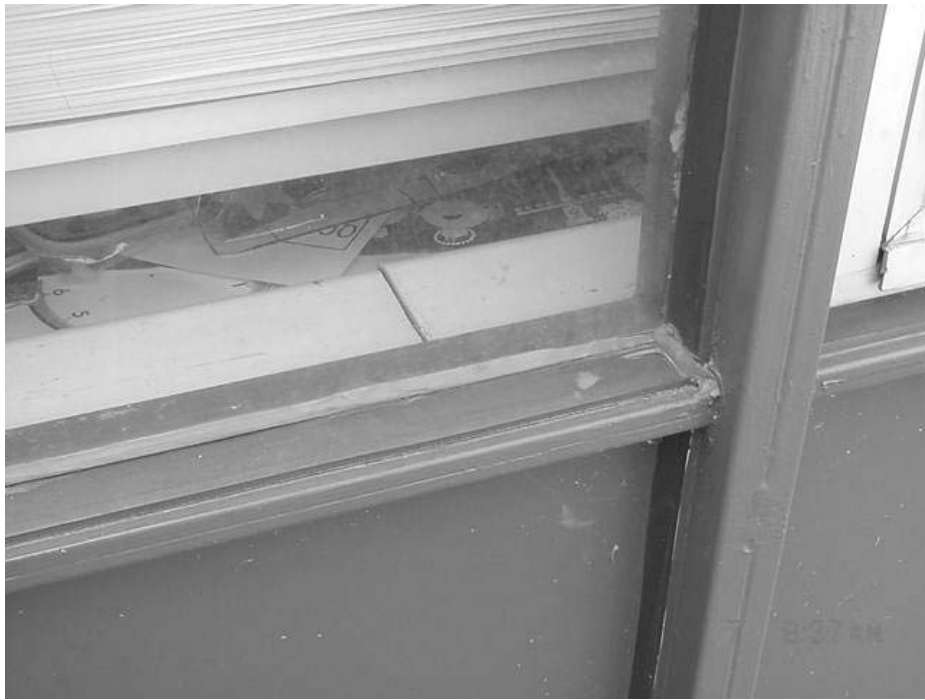
**Picture A-11**

- Replacement of loose/broken window panes throughout the building (A-11 and A-12). At the time of the reassessment the large majority of windows had been replaced with the remainder to be done over April/Summer vacation 2006.
- Re-caulking/sealing of window systems (A-11 and A-12).
- Installation of weathertight exterior doors (Picture A-12).
- Wall panels were replaced and outfitted with “backer rods” which prevent water penetration through the building envelope.
- Drainage was improved around the exterior of the building by creating an asphalt apron at the base of exterior walls to direct water away from the building towards drains (Pictures A-13 and A-14).

**Replacement of Windows and Resealing of Window Panes**

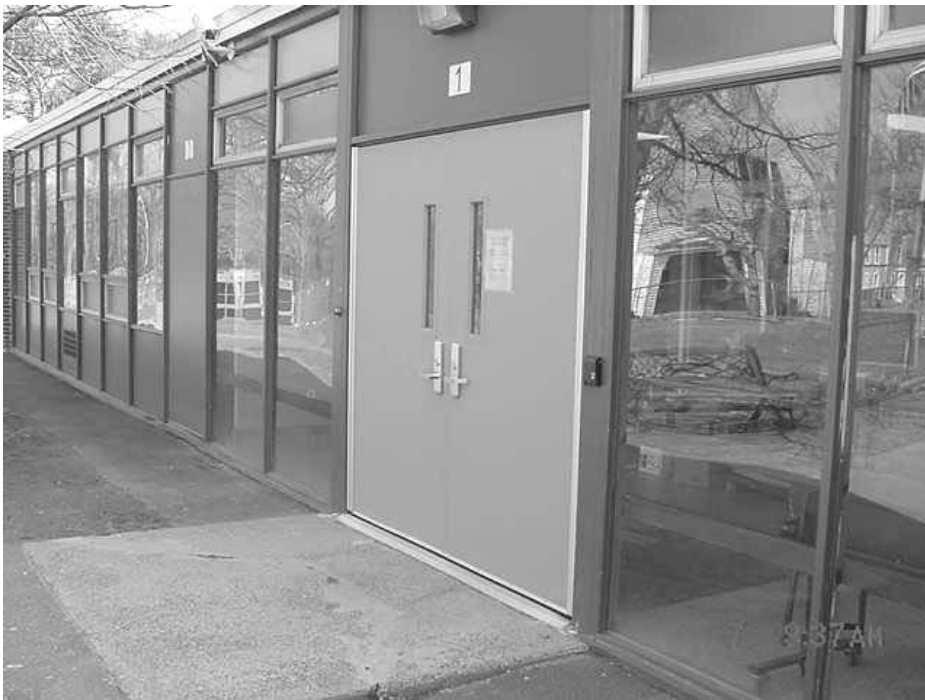
**Picture A-12**

**New Window Panes and Exterior Door**

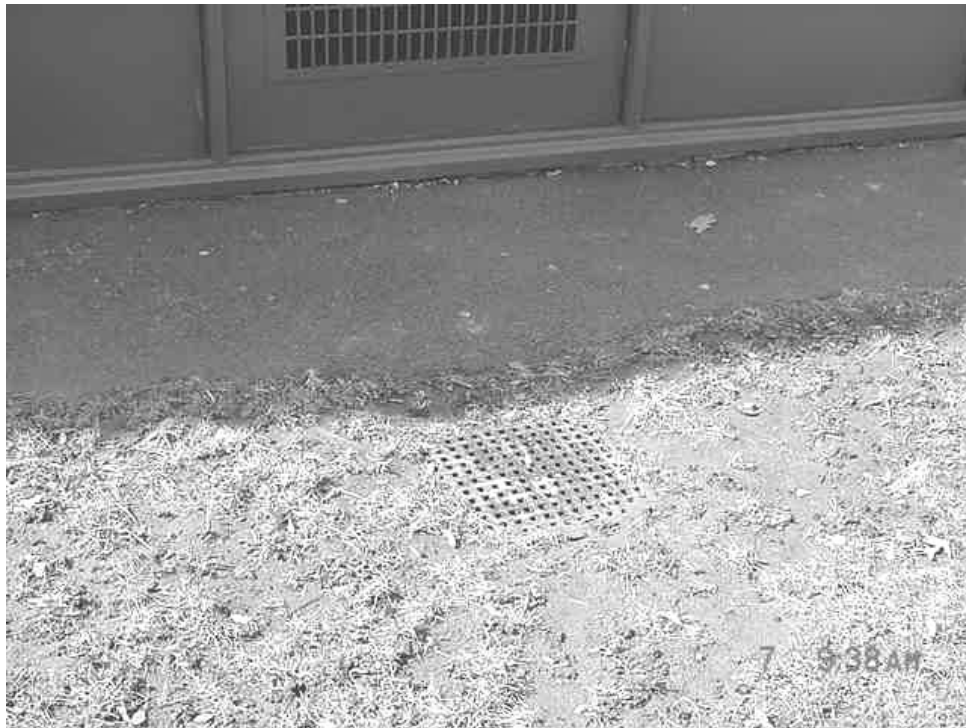
**Picture A-13**

**Asphalt Apron Directing Water away From Building towards Drain**

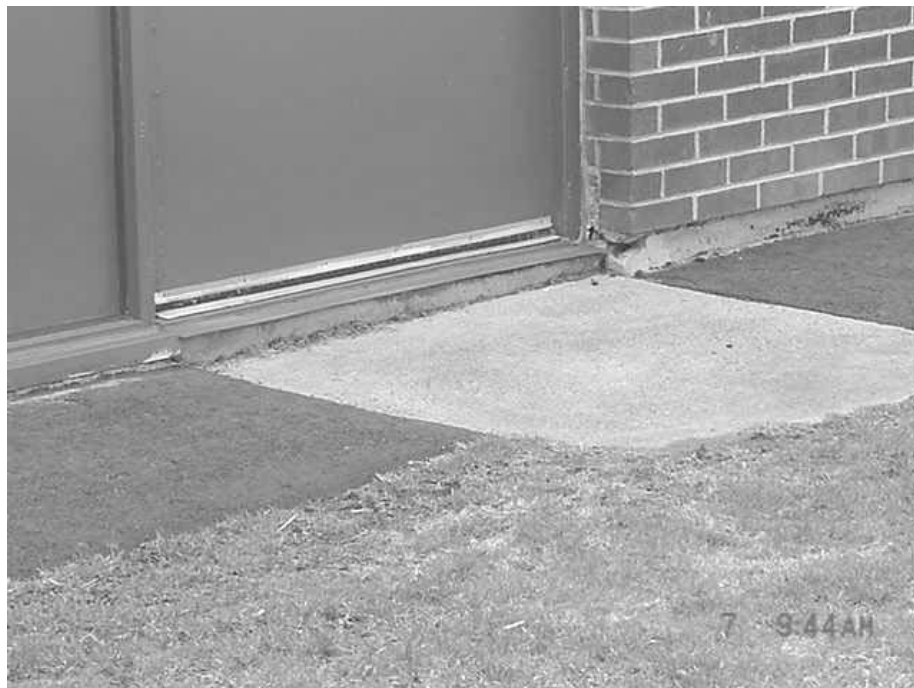
**Picture A-14**

**Asphalt Apron Directing Water away From Building**
